United States
Environmental Protection
Agency

Site Update

San Jacinto River Waste Pits Superfund Site

January 2016

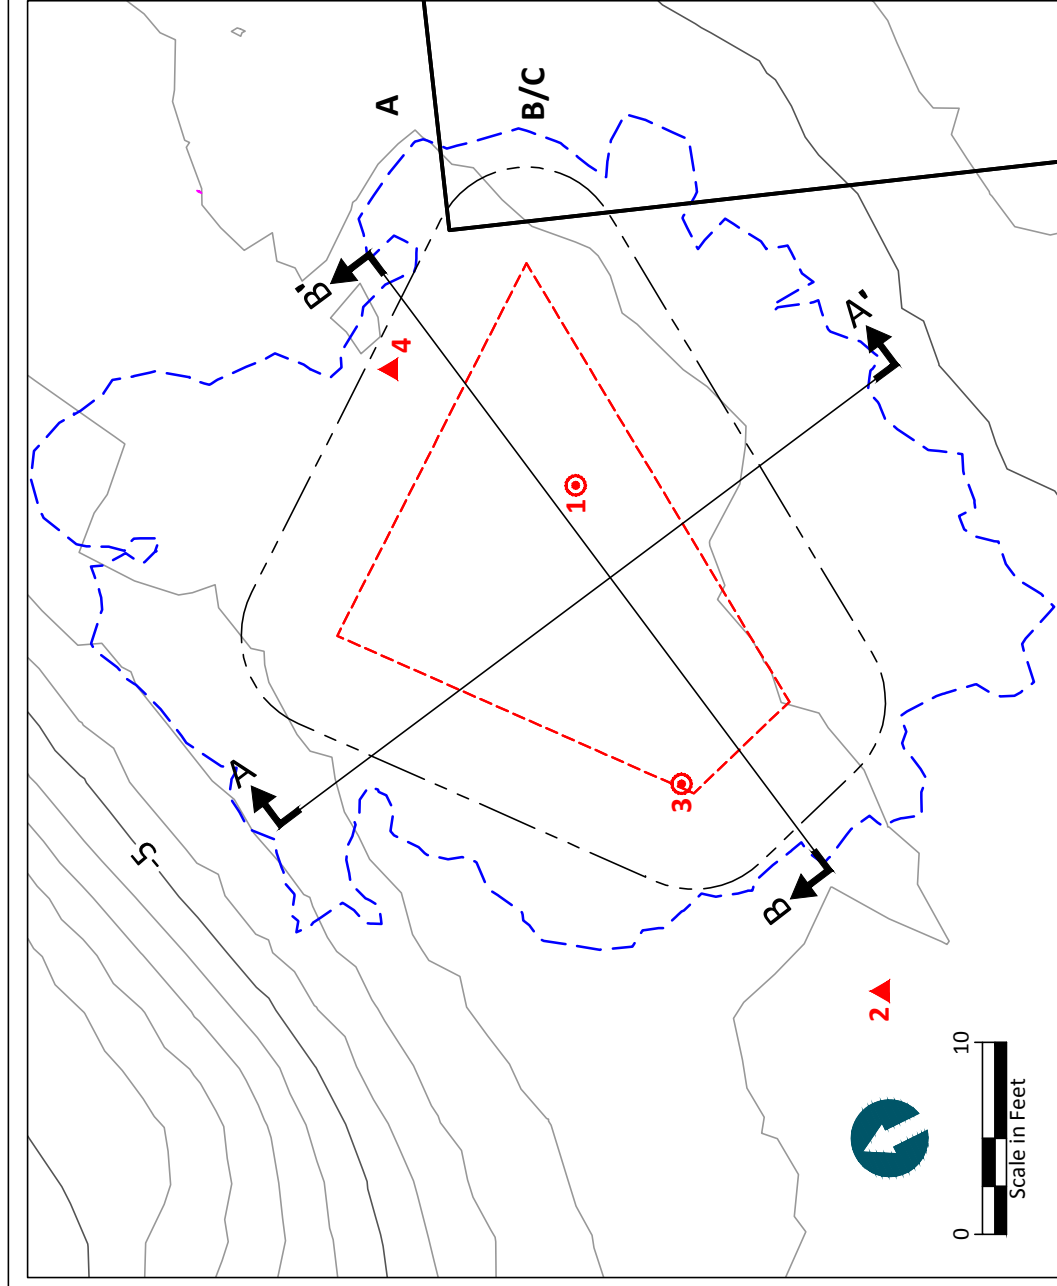
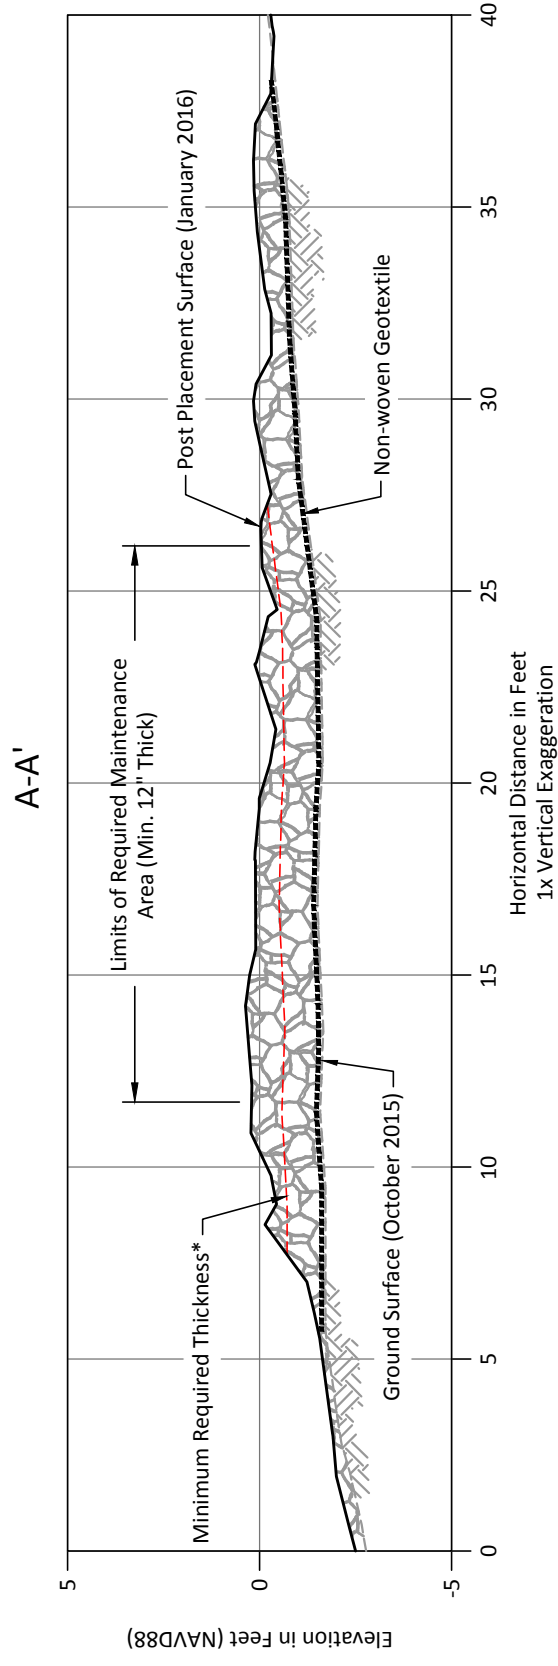
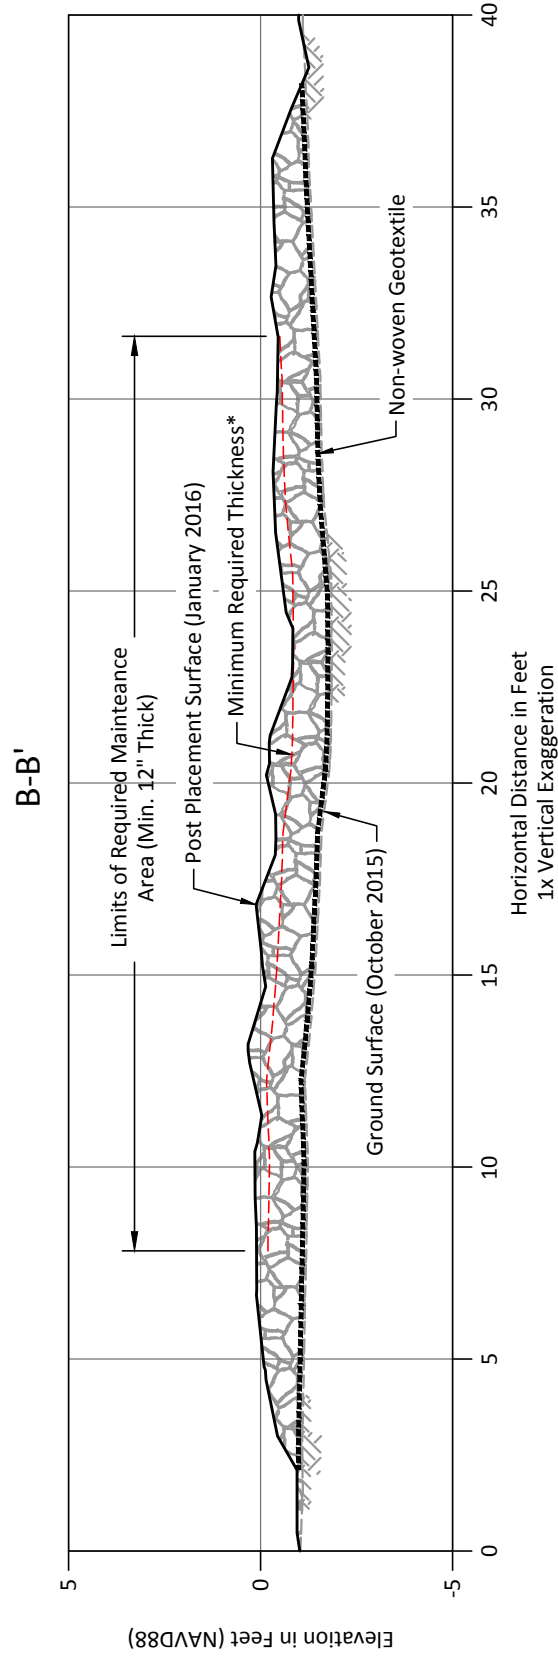
Figure 1
 Armor Rock Placement Plan and Cross Sections
 Post TCRA Inspection
 San Jacinto River Waste Pits Superfund Site

As part of the EPA's oversight responsibility, and to verify the condition of the cap, EPA divers completed an underwater inspection of the armored cap on December 10, 2015. The inspection found an area on the northwest part of the cap where the armor cap was deficient. This underwater area does not have a geotextile liner under the rock, and a gap in the armor cap resulted. The EPA directed both International Paper and Industrial Maintenance Corporation, the potentially responsible parties (PRPs) for the San Jacinto River Waste Pits Superfund site (Site) in Harris County, to submit a repair plan for the protective cap. The EPA prescribed that the repair plan should include confirmation sampling to assure the EPA that no materials have been released from the site.

Following EPA approval of the PRP delineation and sampling plan, the PRPs completed work to mark out the length and width of the deficient area, as well as collect sediment samples. The deficient area was irregularly shaped approximately 20-feet by 25-feet in size located under water from 8-inches to 18-inches deep.

Following the EPA's approval of the repair plan, the PRPs completed work to lay a geotextile fabric over the deficient area and cover it with a 1-foot minimum thickness layer of armor rock with an 8-inch median diameter. Manual probing was done to confirm that the minimum rock thickness was achieved, and additional rock was added where needed. Oversight of this work was provided by EPA staff and contractor. Following completion of the work, the PRPs performed underwater survey of the repaired area.

* Minimum thickness was field verified by probing.
