San Jacinto River Waste Pits (SJRWP) Superfund Site Technical Document Review: Revised Final Removal Action Completion Report (May 2012)

by Jennifer Ronk and Birnur Guven, Houston Advanced Research Center

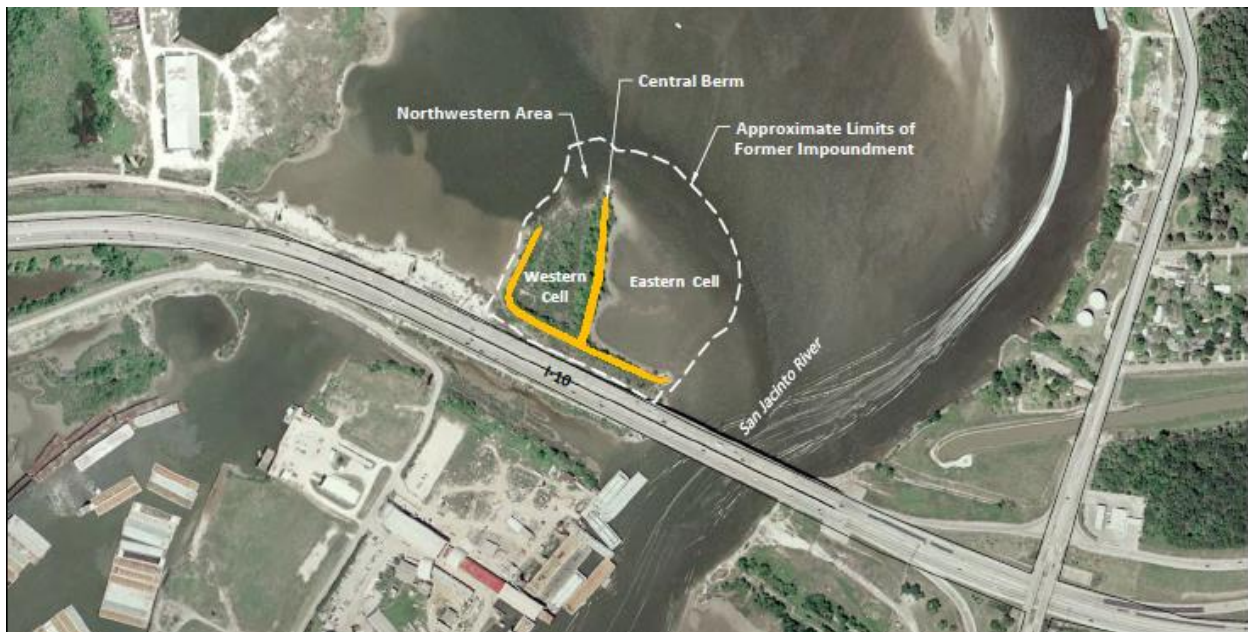
The TCRA site consists of an eastern impoundment and a western impoundment approximately 15.7 acres in size located on a western bank of the San Jacinto River, north of I-10 Bridge. The TCRA Site was subdivided into three areas: Eastern Cell, Western Cell, and Northwestern Area.
